# ZyPer Management Platform Release Notes

Software 2.3.37103

October 21, 2021

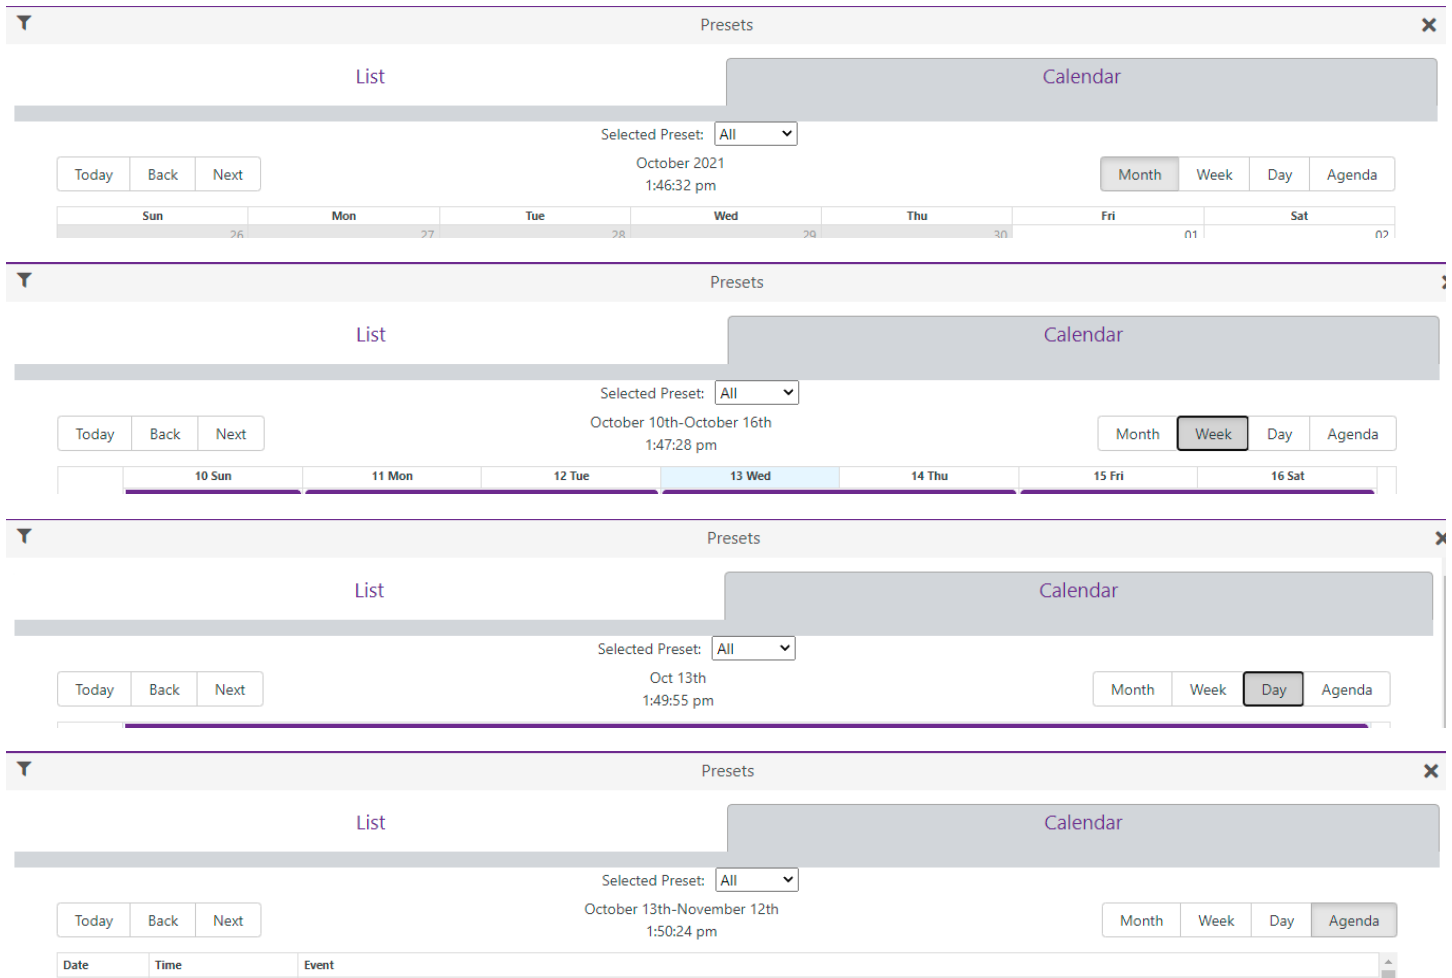
**Appearance and States**

**Overview:** In this release, we have added a time clock for the Preset calendar view under the Month, Week, Day, and Agenda selections. This places a time clock based off of the GUI host machine time in the center top part of the menu. This allows the user to identify the current time and the time of the scheduled presets.

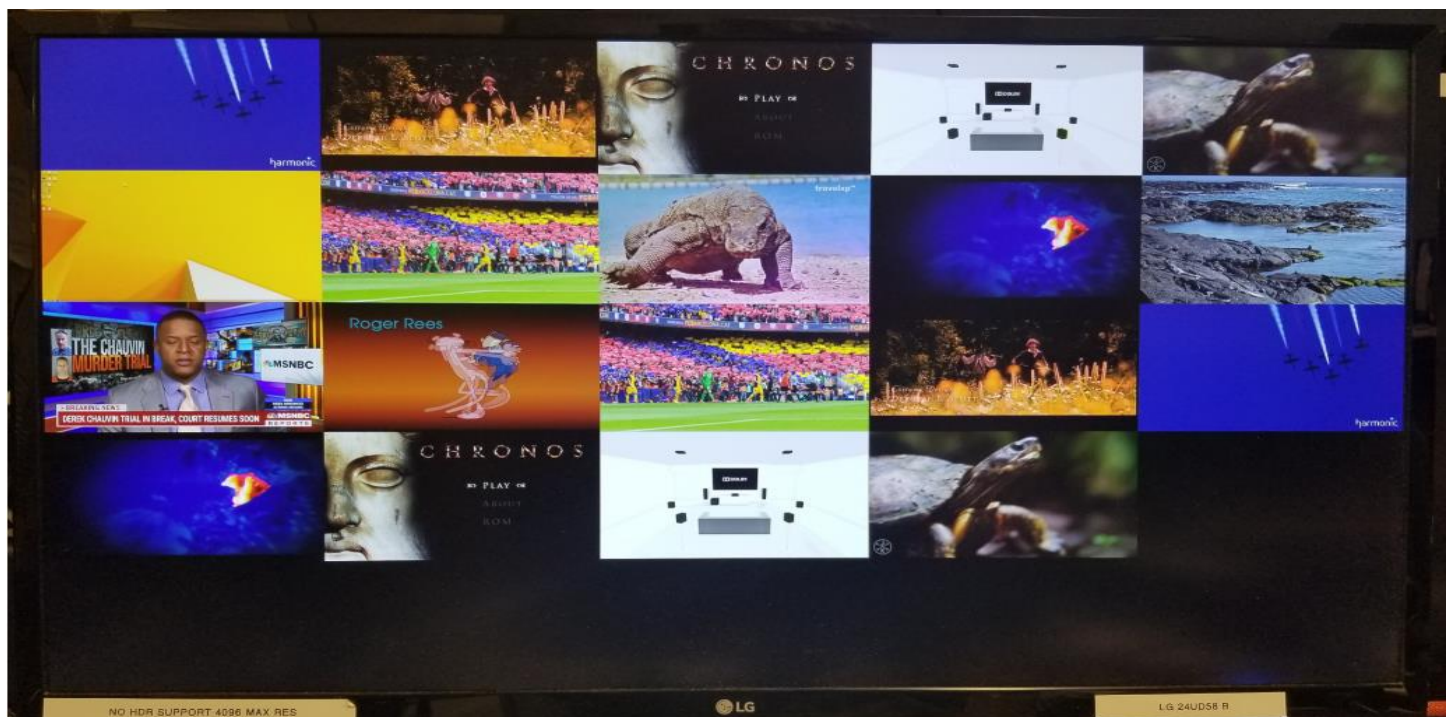
Multiview 19 window support GUI

**Overview:** In this release, we have added the ability to see up to 19 Multiview windows under the GUI. This matches the max windows in the API that can be assigned to a Multiview. This removes the GUI limitation of 9 windows as a maximum seen under the GUI.

Above is the max window allowed in the Multiview configured, below is a representation of these windows when populated by active encoders.
