# **ZyPer Management Platform Release Notes**

Software 3.2.39546

December 6<sup>th</sup>, 2023

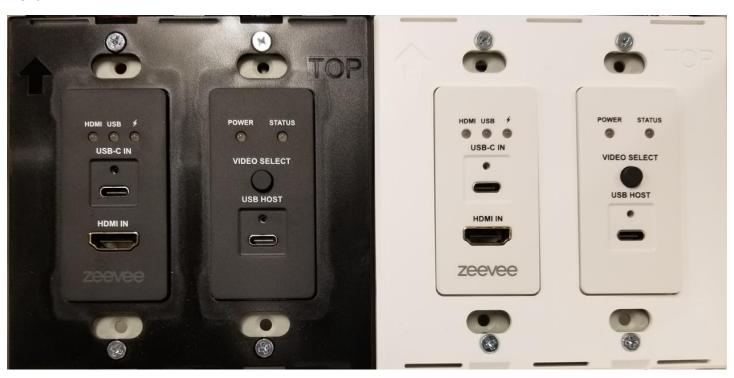
#### **Front**

#### 2E and 2EA
