## **ZyPer Management Platform Release Notes**

Software 4.1.0.41828

November 19th, 2025

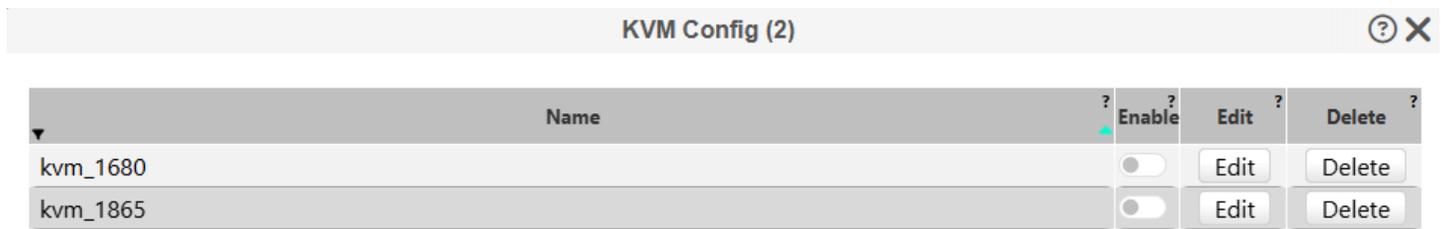
Under the main panel you will be able to select to create a new KVM, Edit an Existing one, delete and enable or disable KVMs from a top view.

In addition, management of the HotKey is available to allow the user to configure the keys used to switch between the active KVM windows from the source keyboard.
